**OTTAWA SPRAY RIG TESTS OF AN ICE PROTECTION SYSTEM
APPLIED TO THE UH-1H HELICOPTER**

Lockheed-California Company
P.O. Box 551
Burbank, Calif. 91520

November 1976

Final Report for Period January 1976 - May 1976

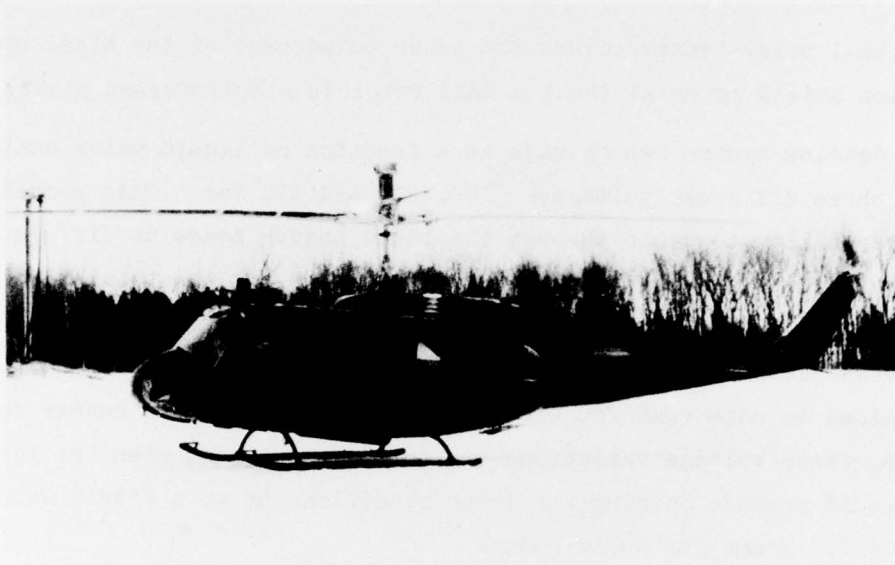
Figure 2. Test Aircraft Following a 30-Minute Run
at -10°C , 0.5 g/m^3 Spray Cloud

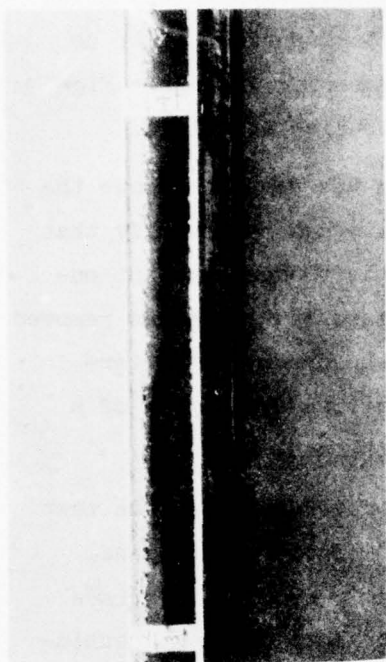
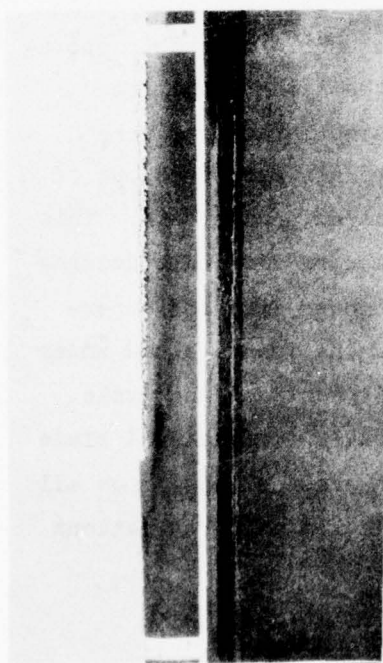
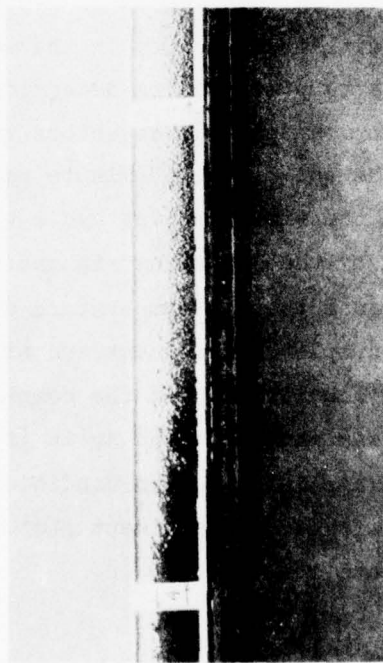
Figure 6. Rotor Blade Ice Distribution with 1/4-inch at 50% Span-Blade Lower Surface Following 3 Minutes at -110C and 0.55 g/m³ IWC

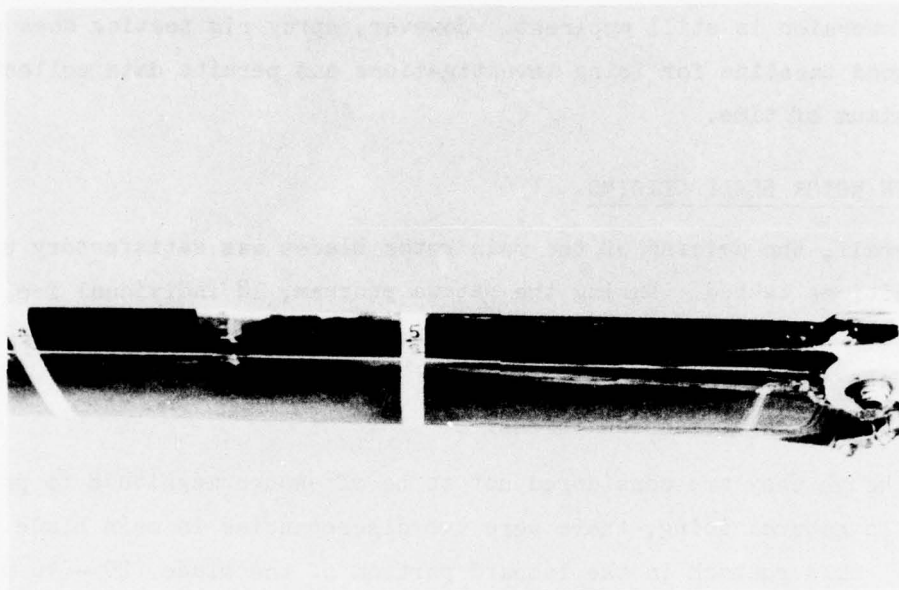
Although they are considered not to be of enough magnitude to preclude testing in natural icing, there were two discrepancies in main blade deicing: mild runback in the inboard portion of the blade (20 - 40 percent span), and residual leading-edge ice of varying magnitude in the same area. The latter and possibly both appear to be caused by the manufacturing joint in the heater and erosion shield at Station 83 (29 percent span). At this station, two design features are concluded to be responsible for the imperfect deicing. The erosion shield material thickness changes from 0.016-inch aluminum over the inboard "doubler" area of the blade to 0.030-inch steel. This difference in skin thickness results in a step in the blade surface contour that opposes the spanwise shearing action of ice separation. In addition, there is apparently a 1-inch-wide cold band (lack of adequate heater coverage) caused by the wraparound conductor that carries the C phase ac current from the upper blade surface to the lower surface. This joint is approximately the midpoint of zone 5. Figures 8 and 9 are examples of the residual ice on the blade in this area after deicing. The white appearance of the ice at the joint shows the ice has separated (or been melted by the heater) and has an air space under it but was still retained on the blade. Many times the same area would be completely or almost clear of residual ice as shown in Figures 10 and 11. It was found also that the small bumps caused by the strain gage and thermocouple installations impaired deicing. The noninstrumented blade

Figure 8. Residual Ice in Zone 5 After Attempting to Induce Runback With Three Deice Cycles at -14°C and 0.45 g/m^3 LWC

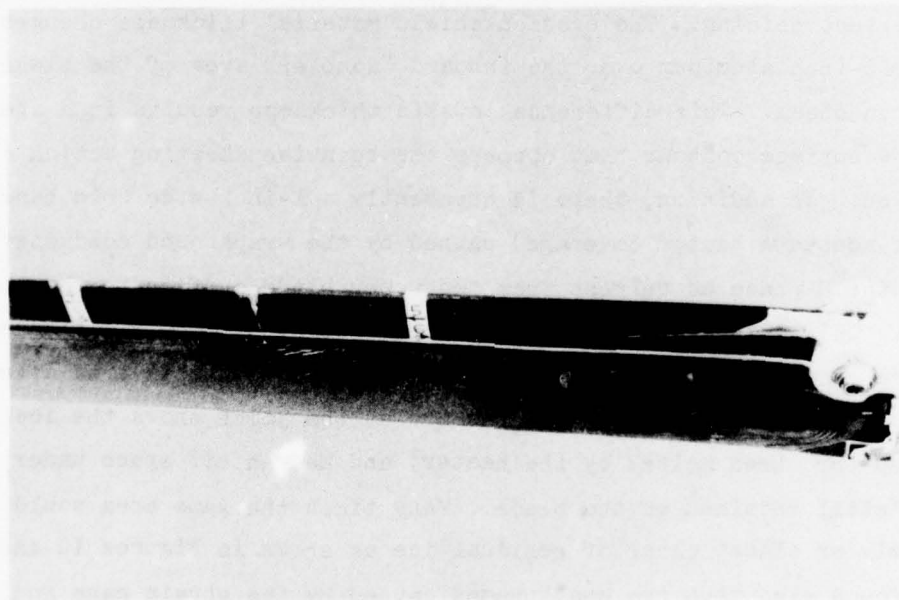
Figure 9. Residual Ice in Zone 5 at -10°C

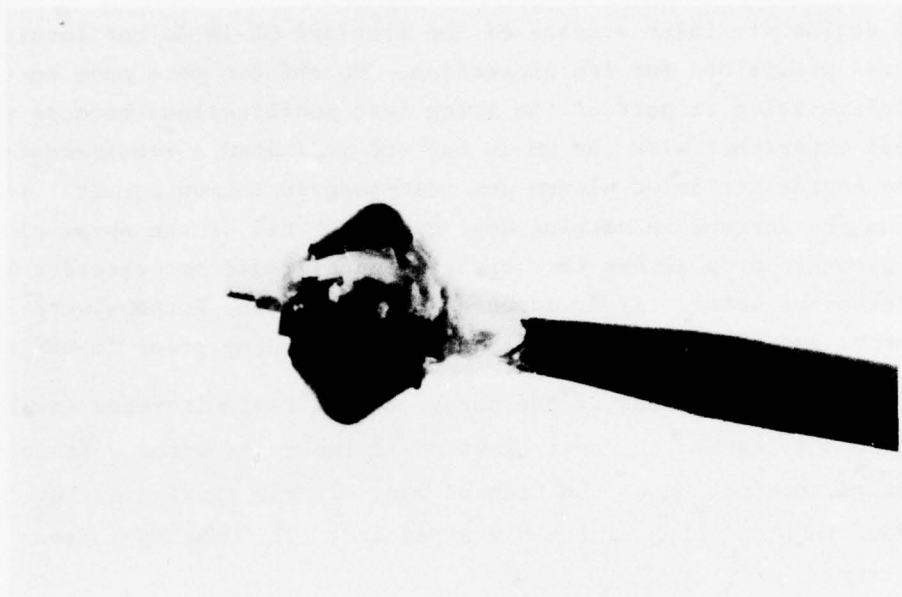
Figure 13. Typical Ice Accretion on the Unheated Portion of the Stabilizer Bar Tip Weight Installation

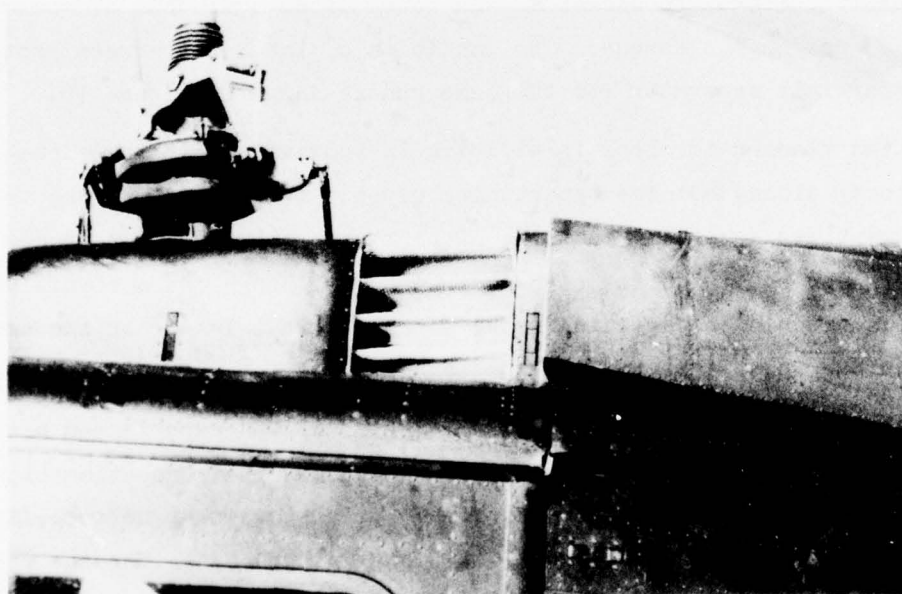
Figure 14. Engine Air Inlet Screen Condition After 30 Minutes in Cloud at -18°C and 0.35 g/m^3 LWC

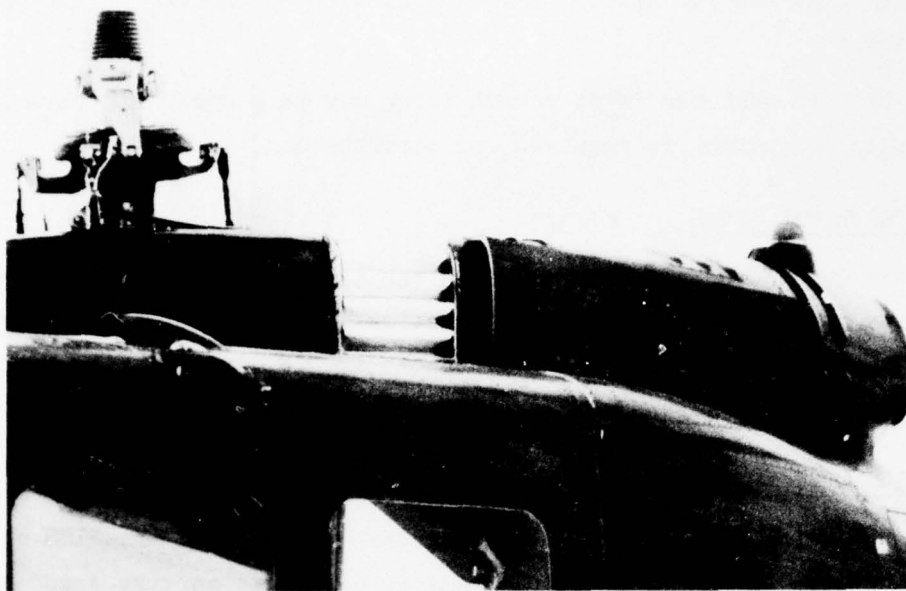
Figure 15. Engine Air Inlet Screen Condition After 5 Minutes in Cloud at -15.5°C and 0.4 g/m^3 LWC While Snowing

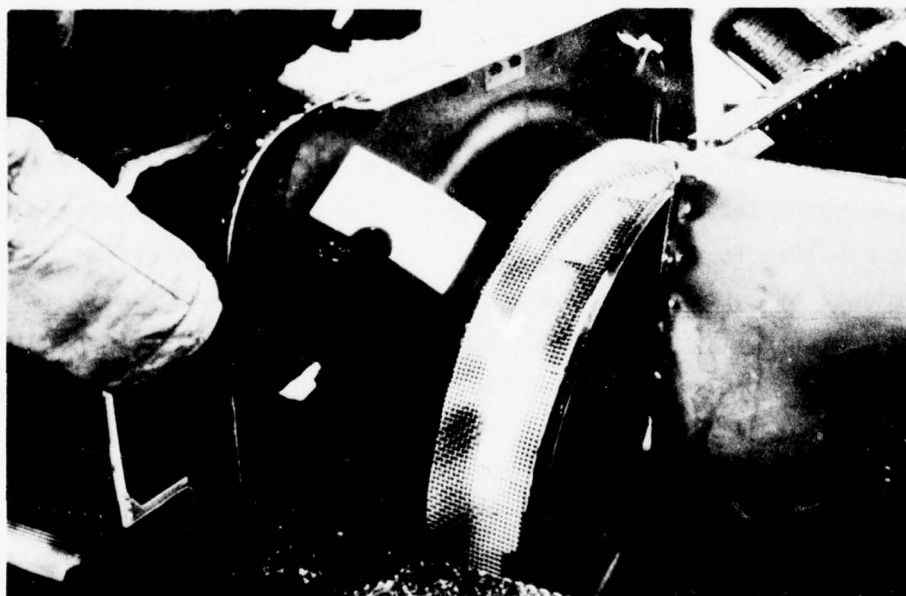
Figure 16. Engine Air Inlet Inner Particle Separator FOD Screen Icing after 5 Minutes at -15.5°C and 0.4 g/m^3 LWC While Snowing

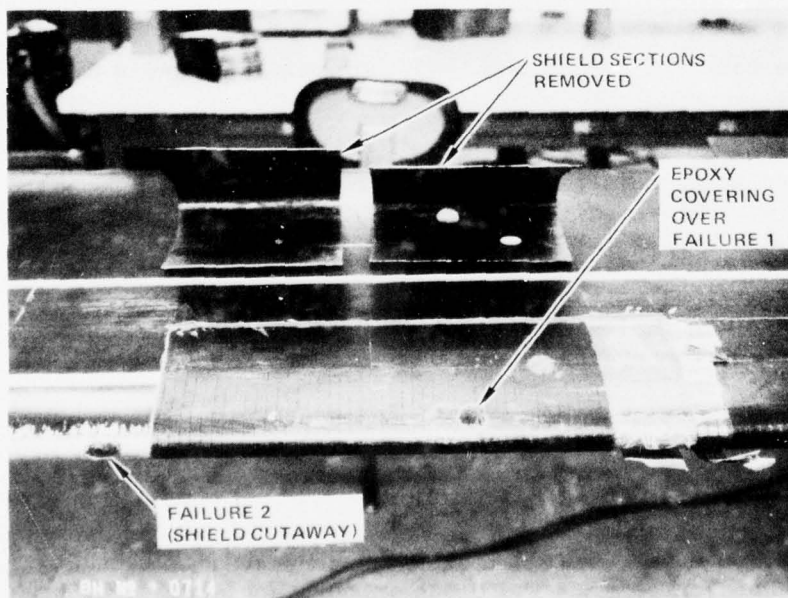
- There was an apparent difference in the insulating glass cloth used inboard of Station 176.6, the zone 2 and 3 boundary, from that used outboard. The cloth inboard appeared to be dry and devoid of any impregnating resin. It is not known whether all the blades were like this, as only one blade was disassembled.

Figure 37. Under the Shield in the Area of the Outboard Failures

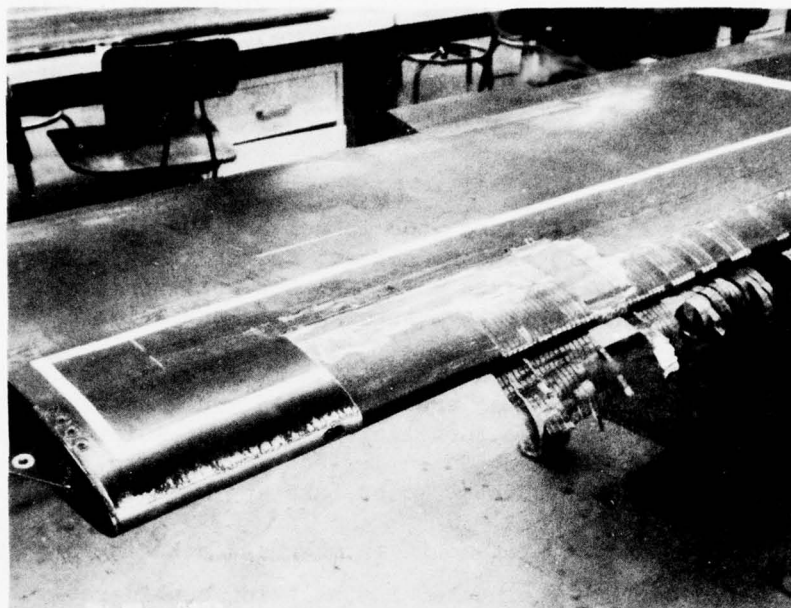
Figure 38. Heater Ribbon Peeled Back in Failure Area

- A few of the solder joints of the lead wire braids to the heater element tabs were not good solder connections and appeared to be similar to a cold joint.

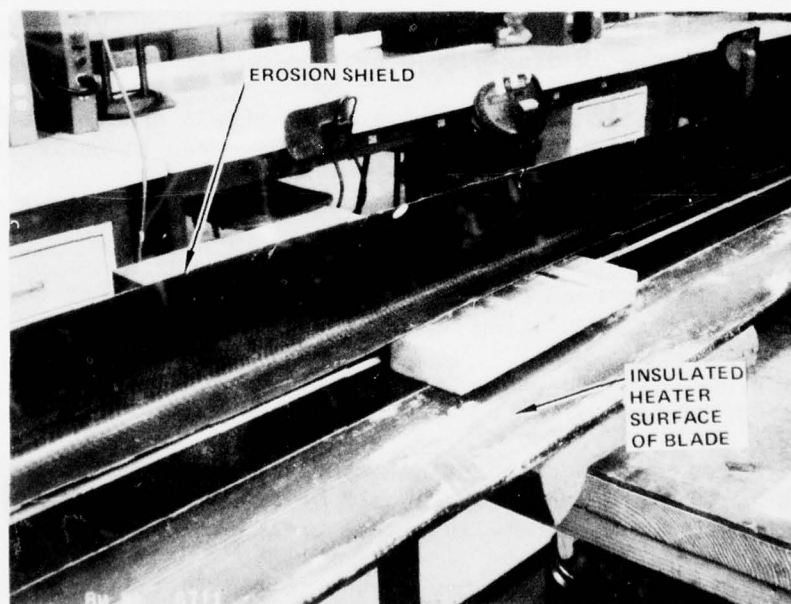
Figure 39. Zones 1 and 2 Inboard of Failure Area
